## STUDY OF INTERGRANULAR CORROSION ON NON-HEAT TREATABLE ALUMINUM ALLOYS IN A COMPRESSOR AFTER-COOLER

Dewa Nyoman Adnyana

*This study was carried out on a compressor heat exchanger (after-cooler) which had a leak in the welded joint of its components made of non-heat treatable aluminum alloys. The purpose of this study is to determine the type and cause, and mechanisms of failure associated with the metallurgical structure that occurs. In this study a number of tests have been carried out including visual and macroscopic examinations, metallographic and hardness testing, and SEM (scanning electron microscopy) analysis equipped with EDS (energy dispersive spectroscopy). The results of the study obtained indicate that the failure mechanism that causes leakage in the aluminum alloy welding joints of the compressor heat exchanger component is intergranular corrosion due to sensitization and the related effect of environmental factors that occur. In addition, the failure may also be affected by welding defect in the form of pinholes.*

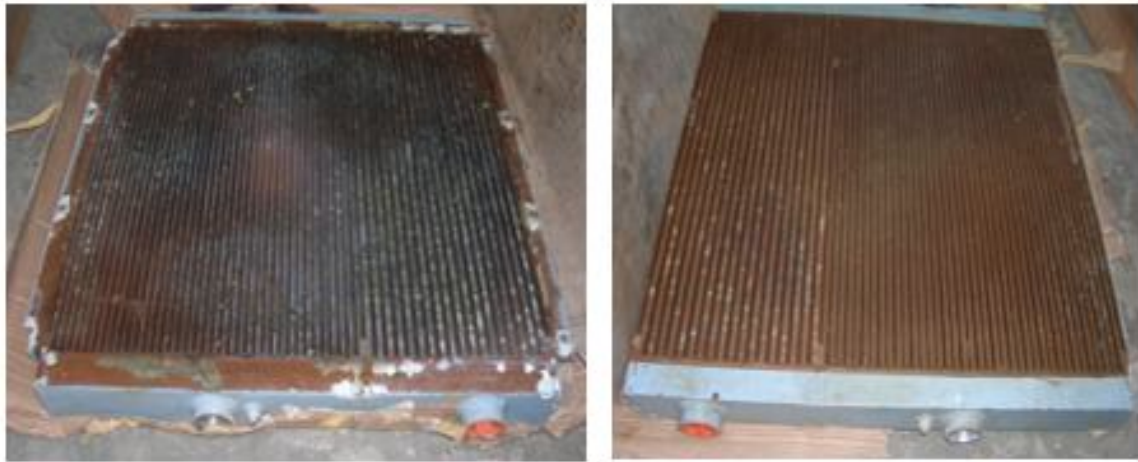
The present work aims to study damage mechanism that has frequently caused a compressor after-cooler to leak. Figure 1 shows a leaked compressor after-cooler that was used for the present study. The after-cooler was equipped with two separated or independent pressure chambers, namely compressor air cooler and compressor lubricating oil cooler. As indicated in Figure 1, the leak is located at the oil cooler around the corroded area on the weld joint between the inlet header and the side bar/parting sheet.

Figure 1. The as received failed compressor after-cooler that was used for the present study

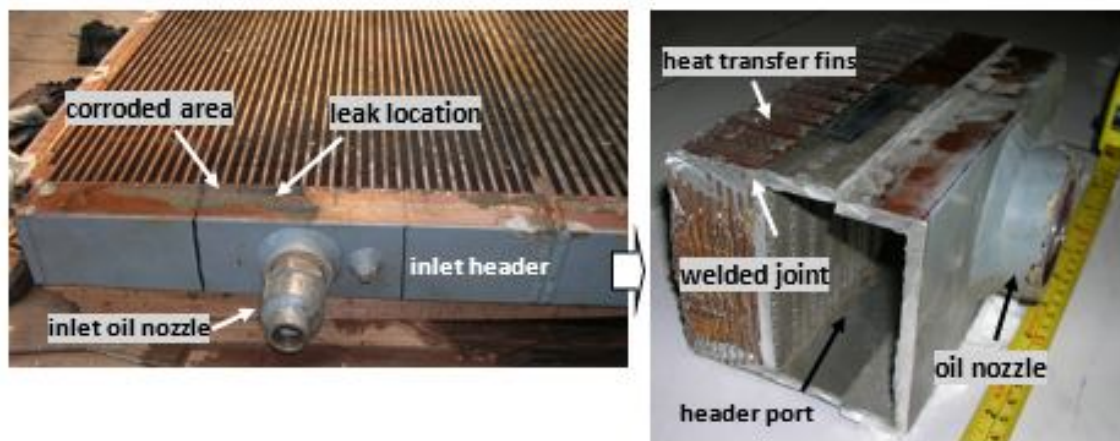
Figure 2. Cutting-off the failed after-cooler around the leak location for sample preparation and examination

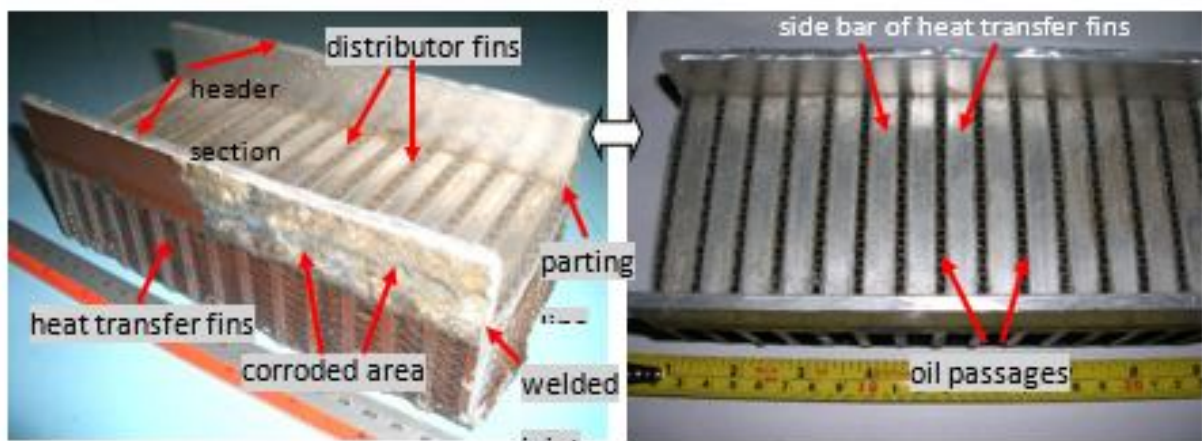
Figure 3. Close up view of the inside header port, showing a number of oil passages containing distributor fins and parting line of the weld joint between header and side bars/parting sheets

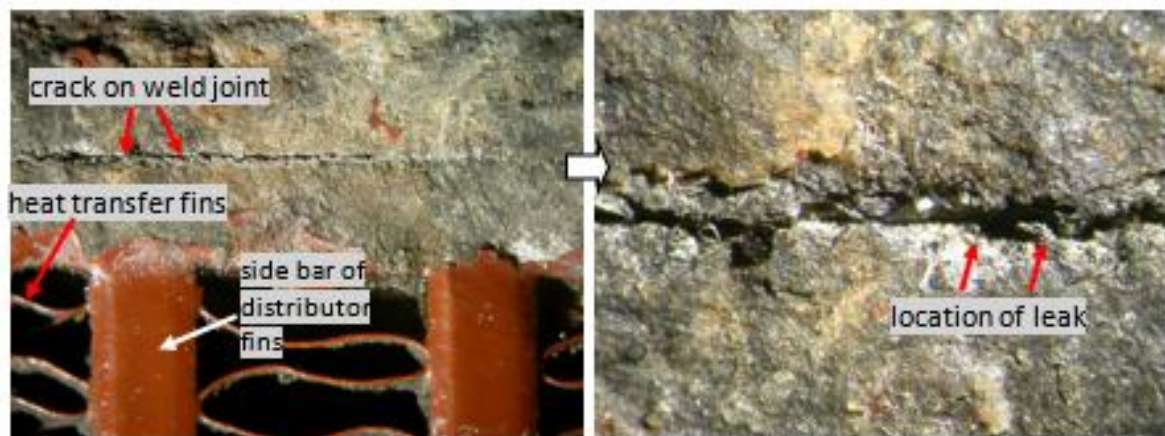
A close up view of the failed after-cooler around the leak location is given in Figure 4. It is seen that the location of oil leak on the after-cooler is a linear crack that formed on the parting line of weld joint between inlet header and side bar/parting sheet.

Figure 4. Close up view of the corroded surface area around the weld joint that caused the after-cooler to leak

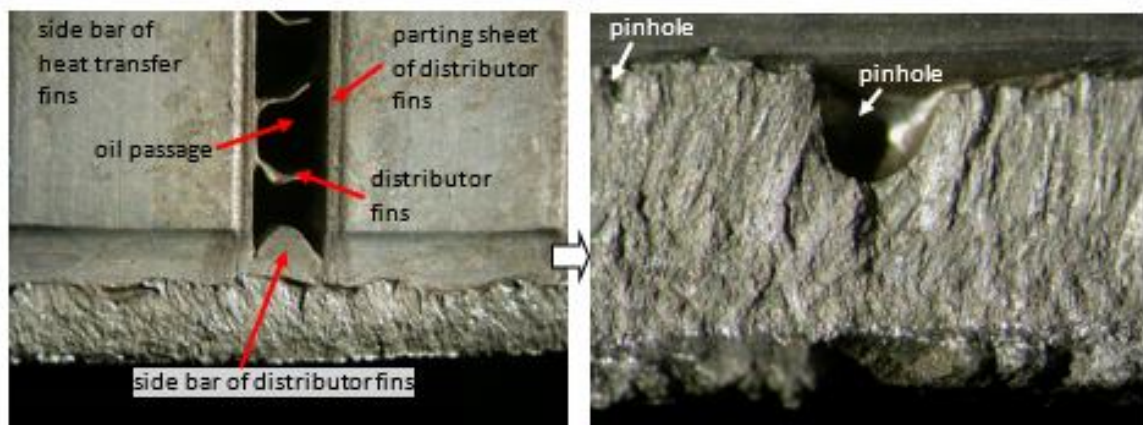
The results of macroscopic examination obtained from some leaked area on the weld joint between the inlet header and the side bar/parting sheet of the compressor after-cooler shown in Figure 4 are presented in Figure 5. It can be seen from Figure 5 that most of the weld surface

fracture apparently contained a number of pinholes due to gas porosity. In addition, some corrosion attack was also indicated to have entered into some surface fracture of the weld. Beside that, the application of one single fillet weld may have further reduced the load-carrying capacity of the weld joint between the inlet header and the side bar/parting sheet and therefore it was prone to cracking.

Figure 5. Surface fracture of the weld joint between header and side bar/parting sheet

In addition to external corrosion and weld defect, the premature failure of the after-cooler was also likely caused by insufficient weld design as the weld joint between the header and the side bar/parting sheet of the after-cooler only used a single fillet weld. The application of another fillet weld on the inside parting line between header and side bar/parting sheet may improve the load carrying capacity of the weld joint structure, and hence it may increase the operating life of the after-cooler significantly.

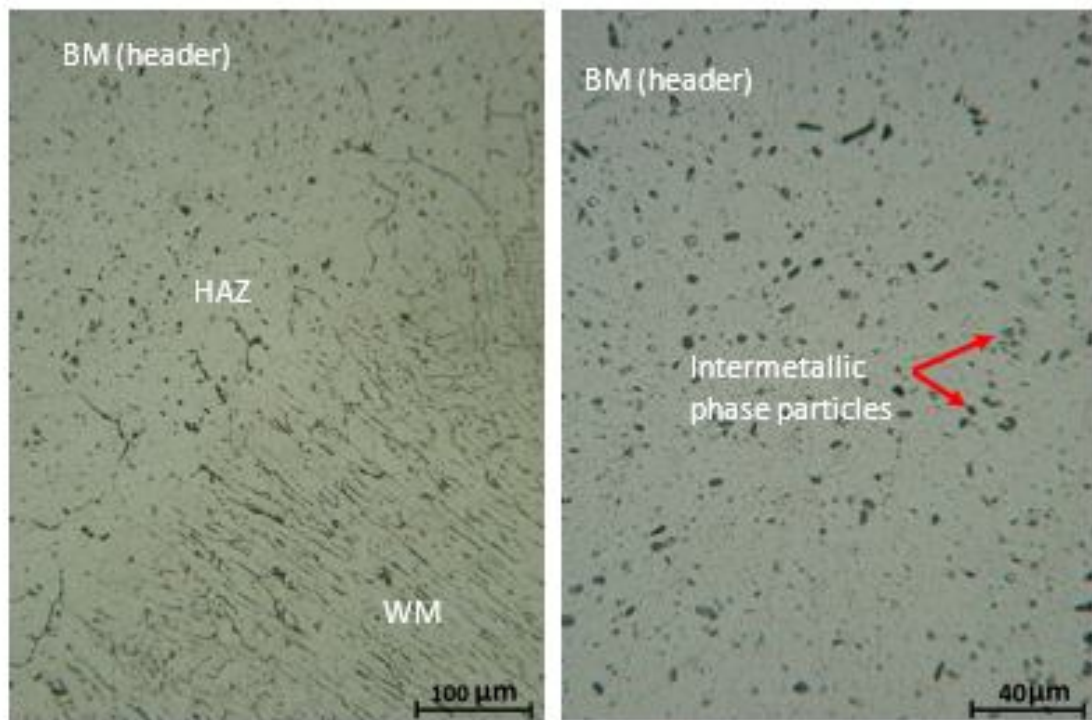
originated from the heavily corroded weld surface. Microstructure obtained from the specimen shown in Figure 6 are presented in Figure 7 at different locations. In the weld joint of the header side shown in Figure 7a, the microstructures obtained are located around the weld metal (WM), heat affected zone (HAZ) and around the base metal (BM). The microstructure of weld metal generally shows a dendritic type, while the microstructure of the header material at its base metal shows typical wrought aluminum alloy microstructure containing fine intermetallic second phase particles [1,2,8-10]. Similar to the macrostructure shown in Figure 5, the microstructure obtained from the weld metal also apparently exhibits a number of large pinholes (see Figure 7b). This further confirms that the fillet weld between the inlet header and the side bar/parting sheet of the compressor after-cooler contained some amount of weld defect. In addition, the microstructures shown in Figure 7b also exhibit some area with heavy damage of external corrosion. The corrosion damage on the weld metal surface in general shows typical interdendritic corrosion. This interdendritic corrosion may have been caused by sensitization that occurred on the weld metal due to formation of a number of intermetallic phases during welding process or in service at extended high temperature exposure [1, 2, 8, 10].

Figure 7a. Microstructure obtained from the weld joint between header and side bar/parting sheet at location X as indicated in Figure 6 (etched with Keller solution). Note BM is base metal, HAZ is heat-affected zone, and WM is weld metal.

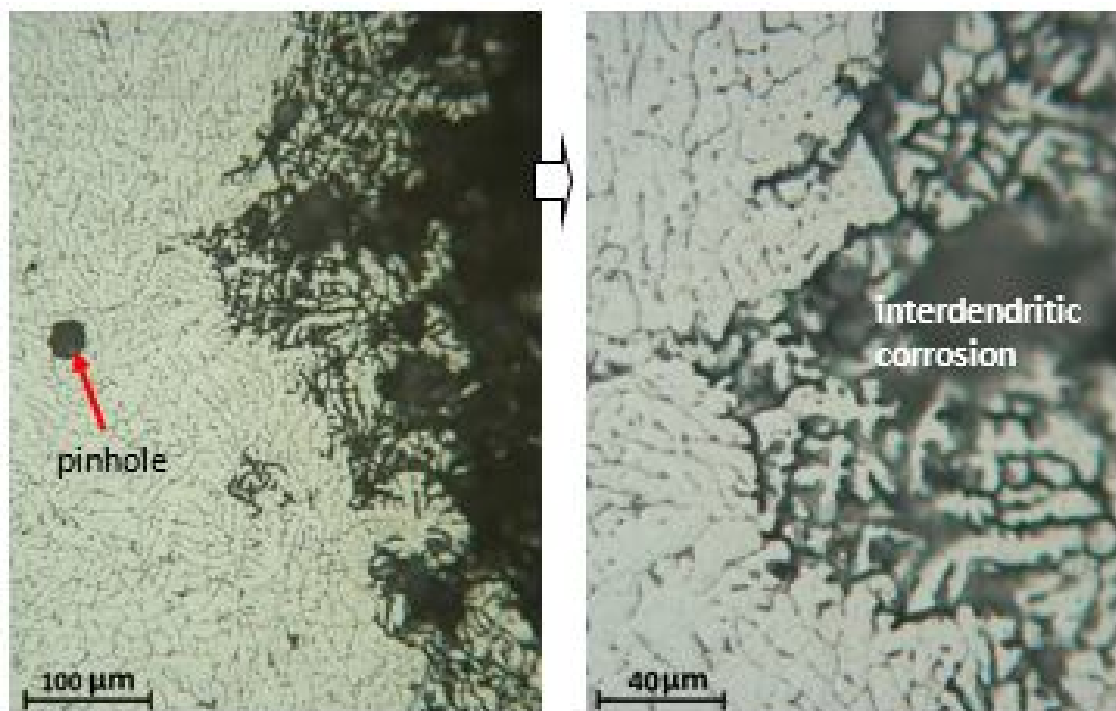
Figure 7b. Microstructure obtained from the weld metal area at header side at location Y as indicated in Figure 6 (etched with Keller solution)

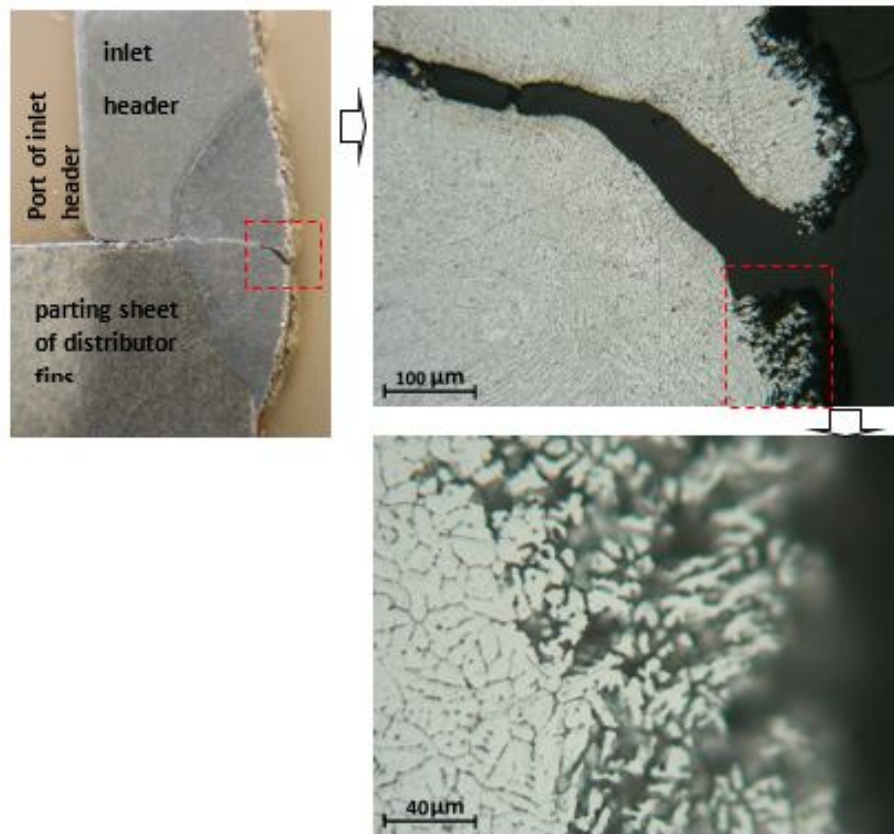
Another specimen for metallographic examination was obtained from the leaked weld joint between the inlet header and the parting sheet of distribution fins (see Figure 8). The microstructures obtained are very much similar with that observed from the previous microstructures shown in Figure 7. The fracture shown in Figure 8 was most likely originated from the corroded weld surface which was heavily

damaged by interdendritic corrosion, and progressed into the internal port of the inlet header through the parting line between the header and the parting sheet of distributor fins. Similarly, the fracture may have also been related with some weld defect (pinholes) that formed in the weld joint between header and the parting sheet.

Figure 8. Microstructure obtained from the weld joint between header and parting sheet of distributor fins at location as indicated (etched with Keller solution)

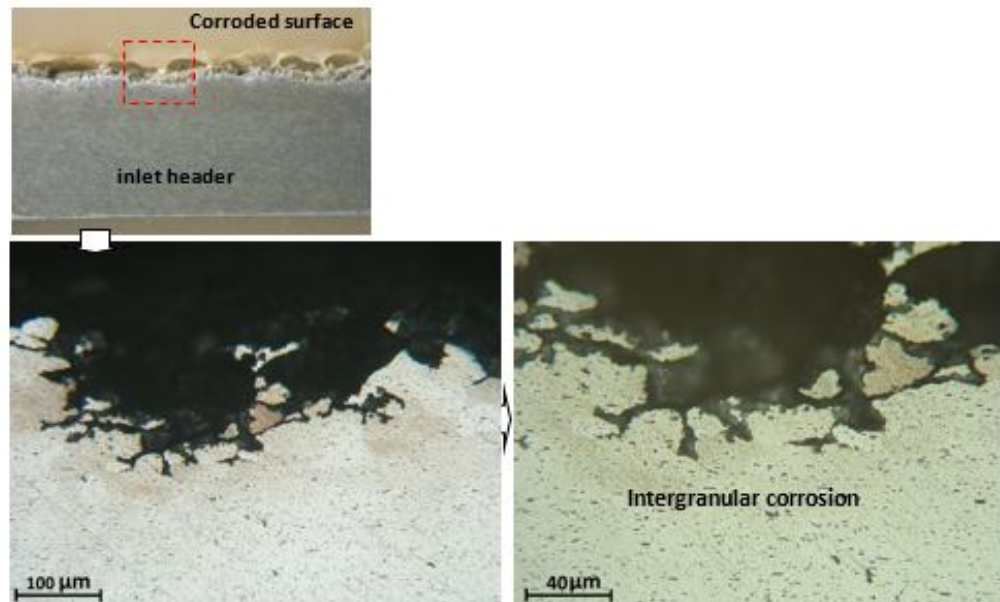
Details of microstructure obtained around the corroded surface area of the inlet header are clearly presented in Figure 9. It is seen that most of the header surface was severely affected by intergranular corrosion. Similarly to the microstructures shown in Figures 7 and 8, this intergranular corrosion was most likely caused by sensitization due to formation of some intermetallic phases at the grain boundaries [1, 2, 8, 10].

Figure 9. Microstructure obtained from the corroded area of the header surface at location as indicated (etched with Keller solution)

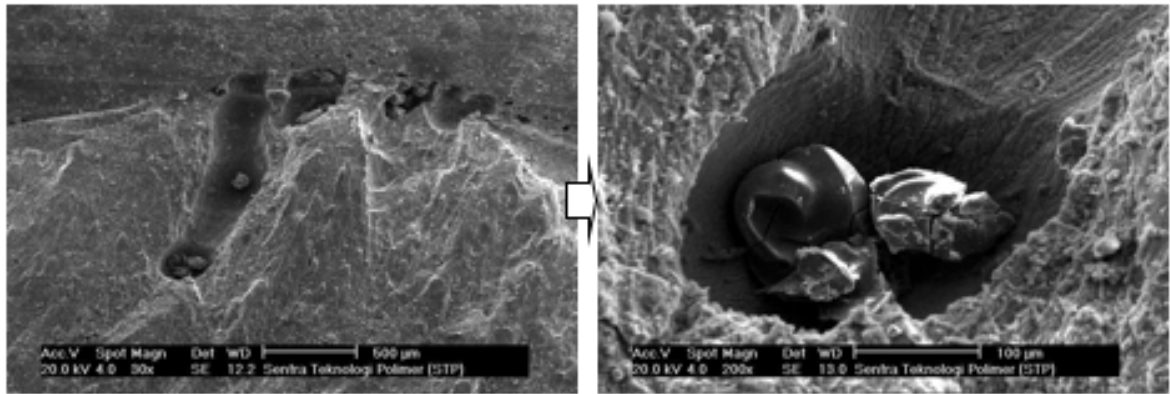
SEM fractographs obtained from surface fracture of the failed after-cooler are presented in Figure 10. The fractographs obtained show the surface fracture of the weld joint between the header and the side bar/parting sheet that apparently contained a number of pinholes. These pinholes in some extent may have contributed to the crack or fracture formation. The crack may have been initiated from the corroded surface of the weld joint and progressed inward to the pinhole area where a high stress concentration may have present. As seen

clearly in Figure 10, one large pinhole was filled with some inclusions.

Figure 10. SEM fractographs of surface fracture obtained from the leak area of the weld joint between the header and the side bar/parting sheet.

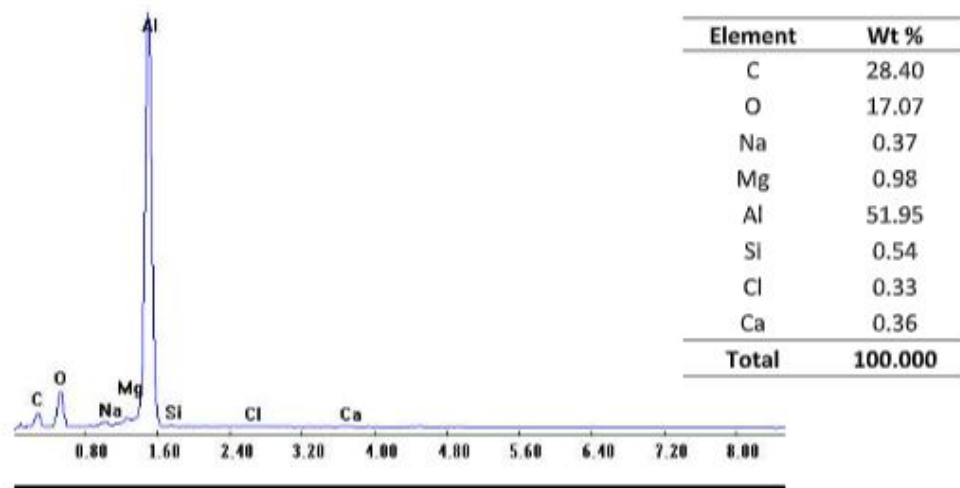
The EDS spectrum obtained from the header surface fracture shown in Figure 10 that experienced corrosion damage shows some major elements such as aluminum (Al), carbon (C) and oxygen (O) (see Figure 11). The oxygen content obtained is much likely affected by the oxide formation due to corrosion (as corrosion product). Whereas the high carbon content found in the EDS spectrum may be influenced by some leakage of hot compressor lubricating oil that entered into the oil cooler. In addition to those elements, there are also other elements observed in the EDS spectrum such as magnesium (Mg), silicon (Si), sodium (Na), chloride (Cl) and calcium (Ca). Both elements of Mg and Si are the alloying elements of the aluminum alloy AA5xxx. The source of Na and Cl was most likely coming from the sea water and/or its moisture contamination, or may be present in other aqueous environment as a contaminant. Figure 12 also shows EDS spectrum of elements representing the corresponding composition of inclusion that formed inside a large pinhole shown in Figure 10. Basically, the inclusion is a typical aluminum oxide that formed from the filler metal during welding.

Figure 11. EDS spectrum of element representing the corresponding composition of the header surface fracture shown in Figure 10.

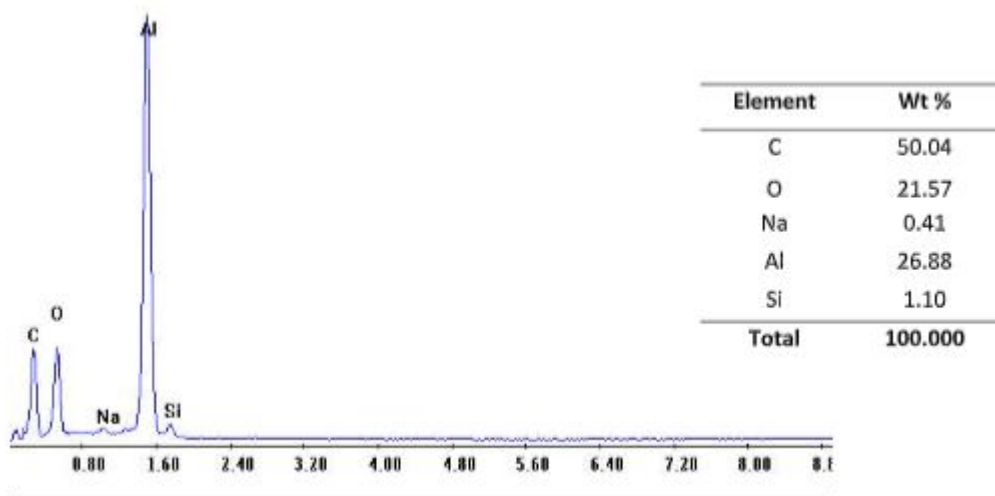
Figure 12. EDS spectrum of elements representing the corresponding composition of inclusion formed inside a pinhole shown in Figure 10

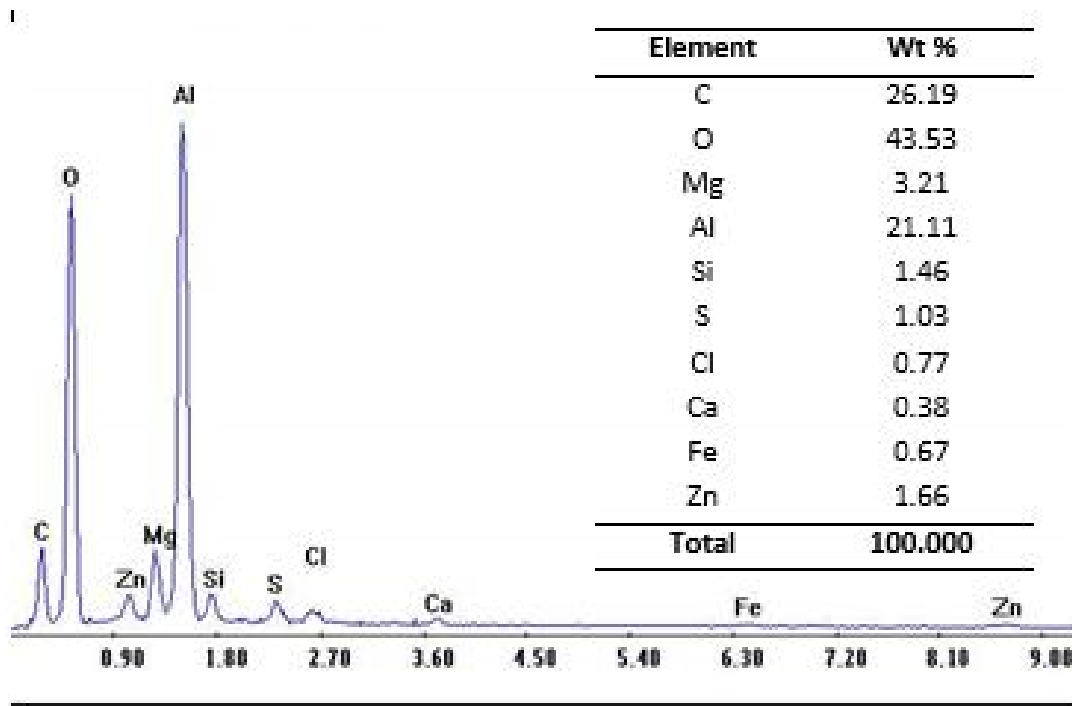
Other result of EDS analysis was also obtained from some corroded surface area located around the edge of the header and close to the weld surface fracture (see Figure 13). Most of the result obtained indicated that oxygen (O) and carbon (C) along with aluminum (Al) and its alloying elements such as Si, Mg, Fe, Zn and some sulfur (S), chloride (Cl) and calcium (Ca) were detected on much of the corroded surface scale/corrosion product.

Figure 13 EDS spectrum of elements representing the corresponding composition of some corroded surface of the header.
